REDUCING THE RISKS OF NONSTRUCTURAL EARTHQUAKE DAMAGE: A PRACTICAL GUIDE

Second Edition

BAREPP

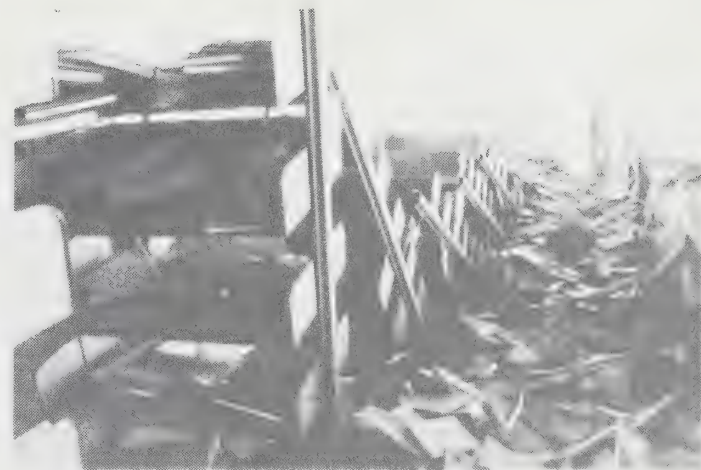
b. Banco Central, 1972 Nicaragua earthquake

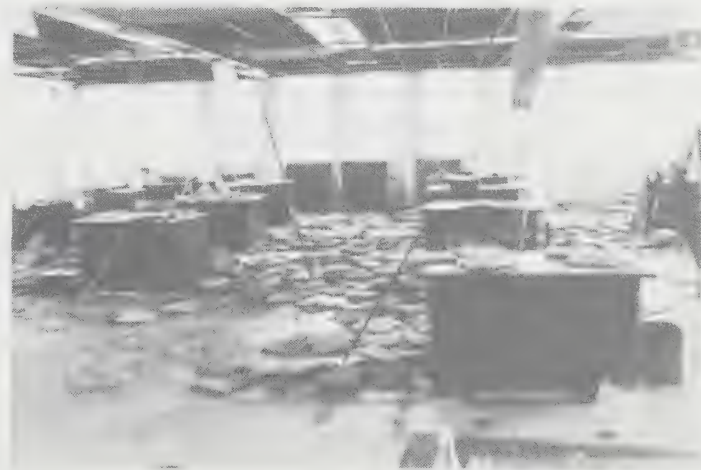
d. Banco Central, 1972 Nicaragua earthquake

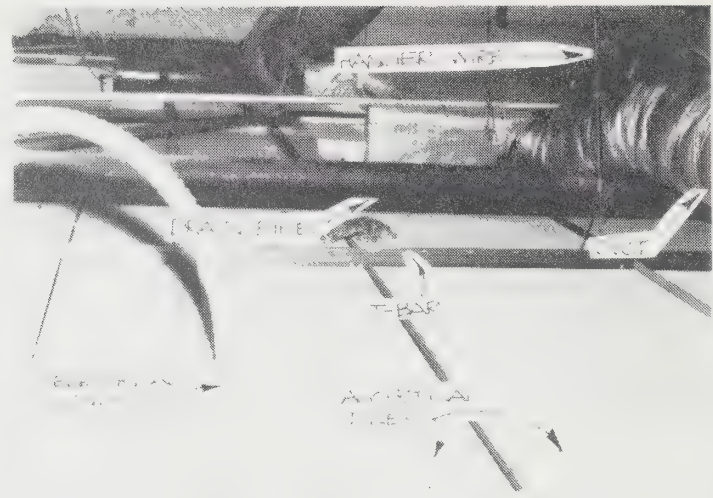
b. Service space above suspended ceiling

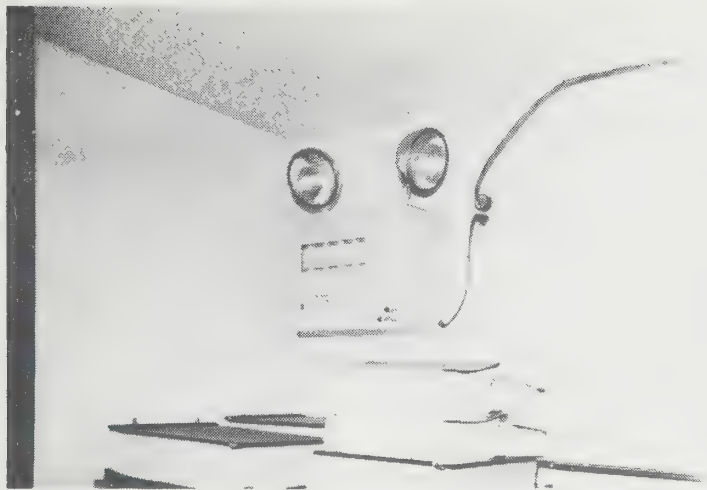
a. Battery-powered emergency lights

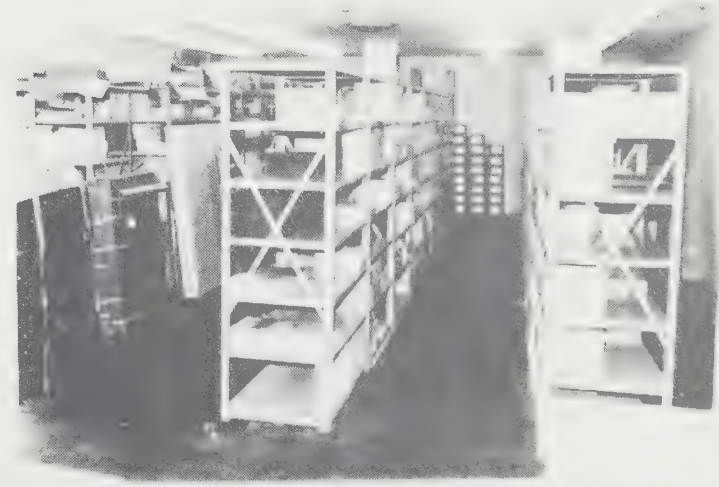
d. Storage room. Shelving is cross-braced, but the entire shelf unit is not bolted down or otherwise stabilized.

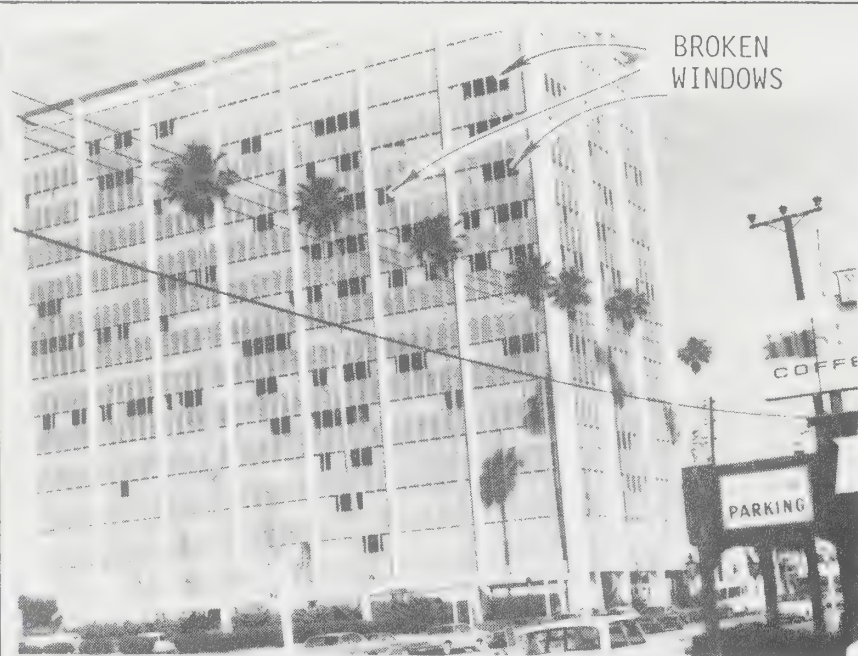
BROKEN
WINDOWS

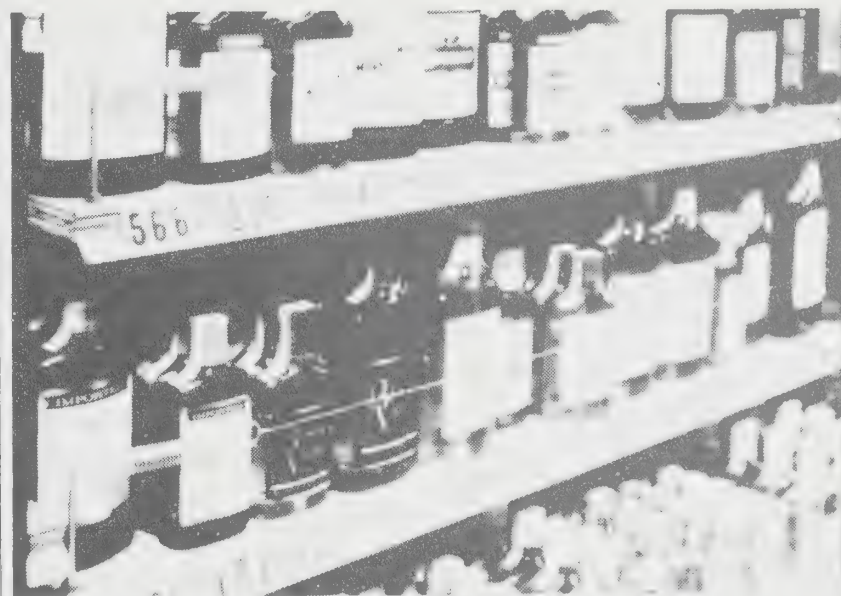
Contents restrained by wire (may not be feasible)

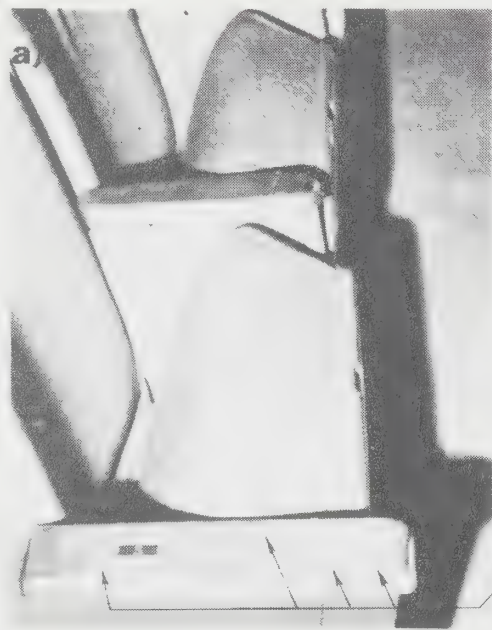
DENTS IN
HARDWOOD
ARMREST
CAUSED BY
FALLING AIR
DIFFUSER

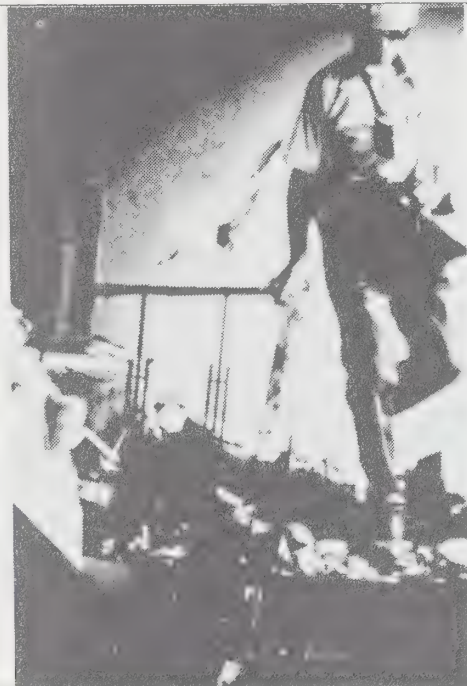
DEBRIS FILLED STAIRWAYS HAMPER EVACUATION OF BUILDING OCCUPANTS

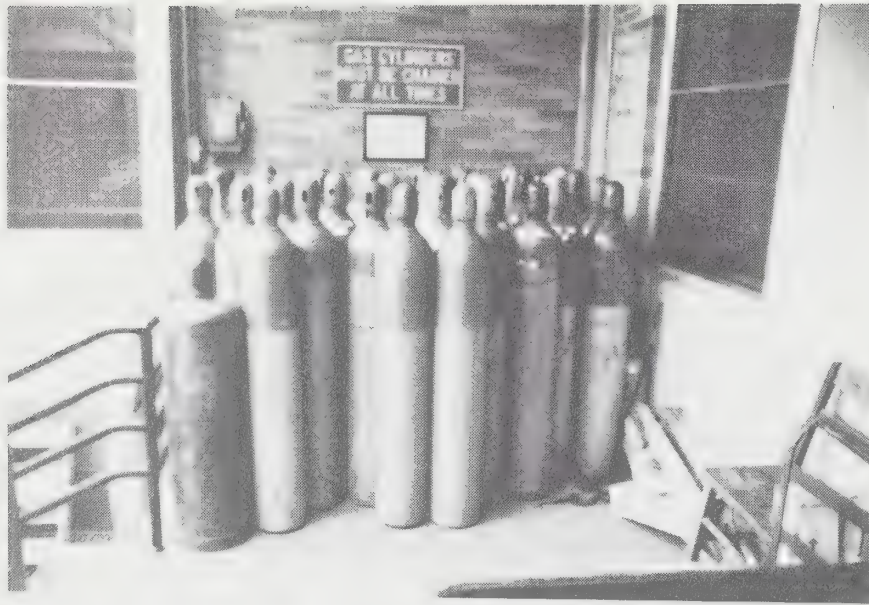
a. Example of a "human" rather than "hardware" problem in maintaining protection from nonstructural damage: the chains provided are not being used.
